July 18, 2025

Subject: Town of Dunn Sanitary District No. 1 - Defective Sanitary Sewer Laterals Update

Photographs from Properties with Major Defects

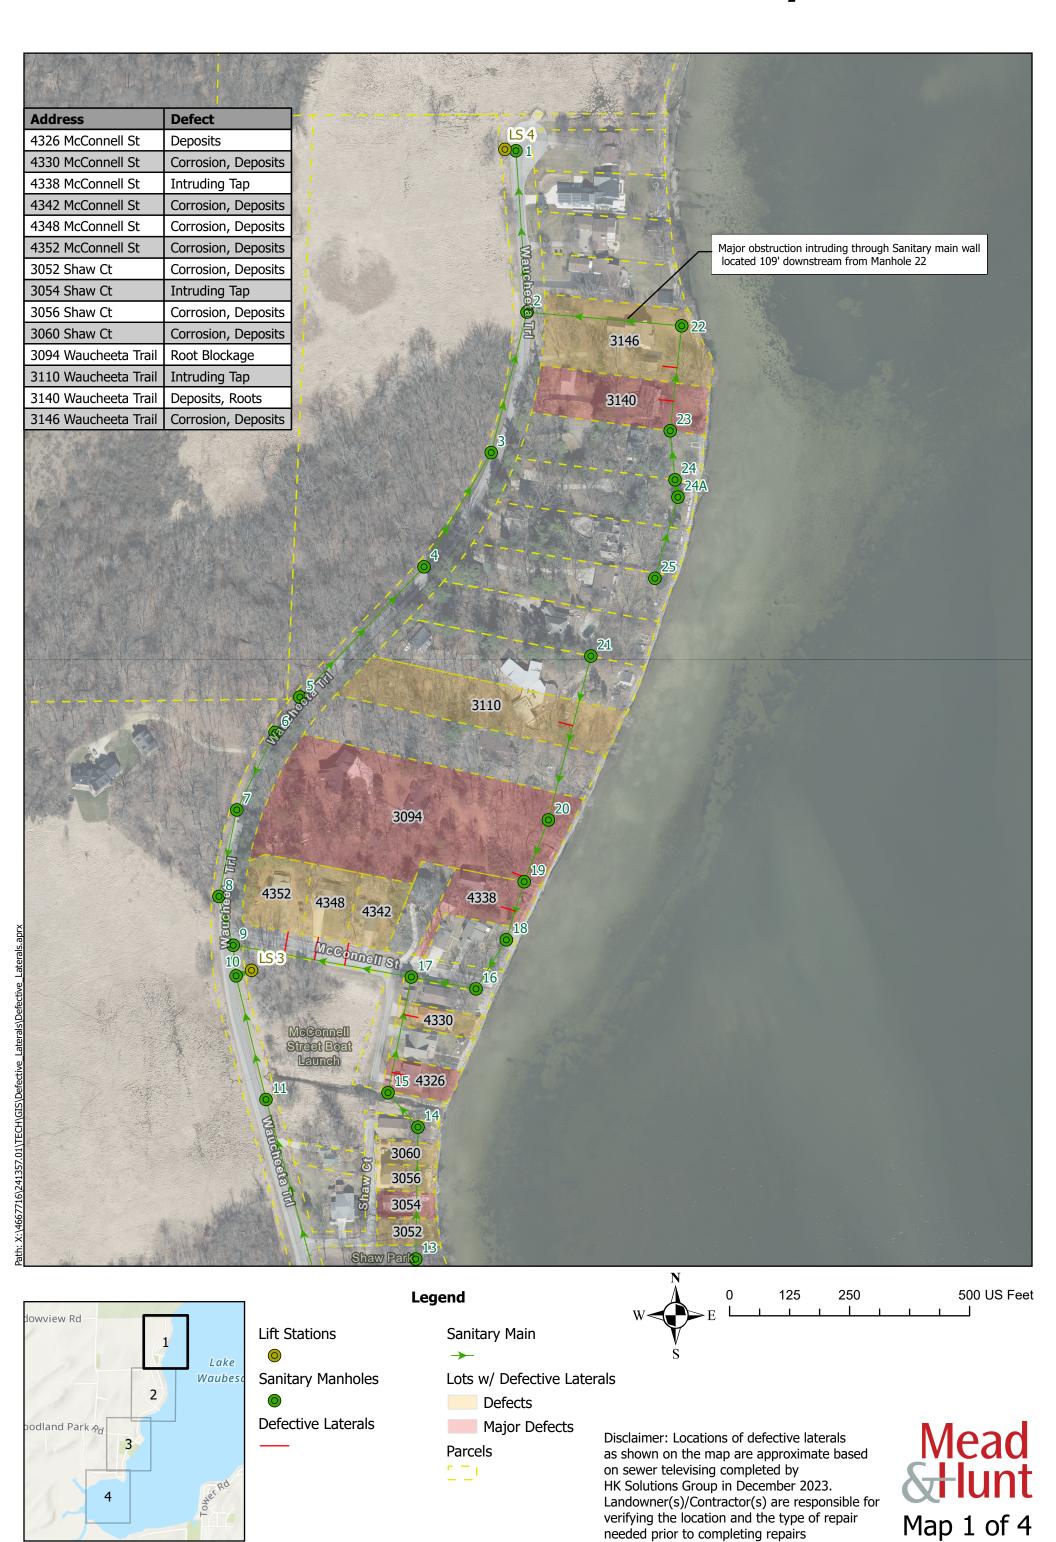
On map 1 of 4, we indicated the location where it appears a small diameter pipe or similar object was installed through the walls of the existing sewer main, causing infiltration of clear water into the sewer. This location is currently planned to be repaired as part of the upcoming DNR Clean Water Fund Program project in 2026. Although this is not a lateral defect, it is included with our documentation in case the District feels the need to contact the property owner prior to the start of the 2026 project.

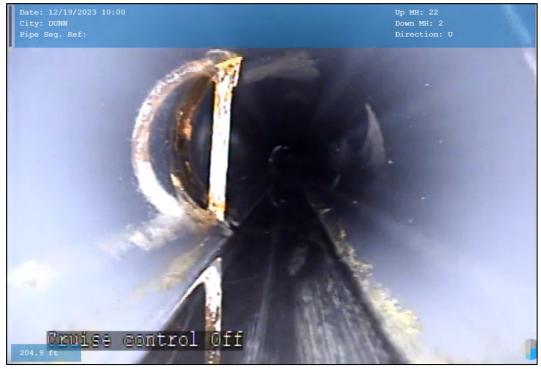
Figure 1: Obstruction through sanitary sewer main pipe wall with infiltration.

Upstream Manhole: 22, Downstream Manhole: 2

Address: 3146 Waucheeta Trail

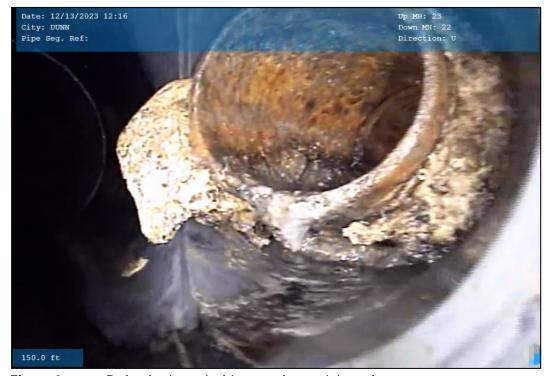
Figure 2: Defective lateral with corrosion and deposits.

Upstream Manhole: 23, Downstream Manhole: 22

Address: 3140 Waucheeta Trail

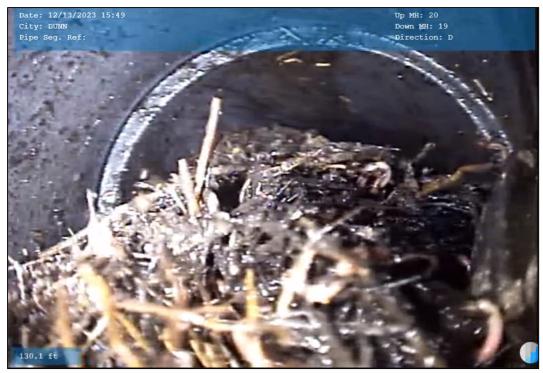
Figure 3: Defective lateral with root blockage.

Upstream Manhole: 20, Downstream Manhole: 19

Address: 3094 Waucheeta Trail

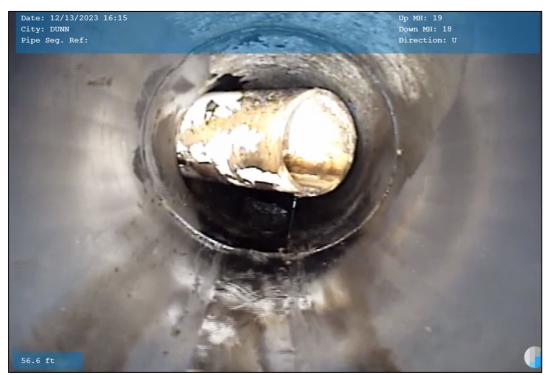
Figure 4: Lateral with tap intruding into sanitary sewer main.

Upstream Manhole: 19, Downstream Manhole: 18

Address: 4338 McConnell St.

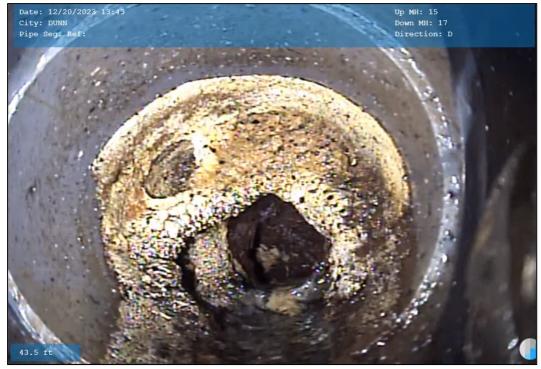
Figure 5: Defective lateral with deposits/blockage.

Upstream Manhole: 15, Downstream Manhole: 17

Address: 4326 McConnell St.

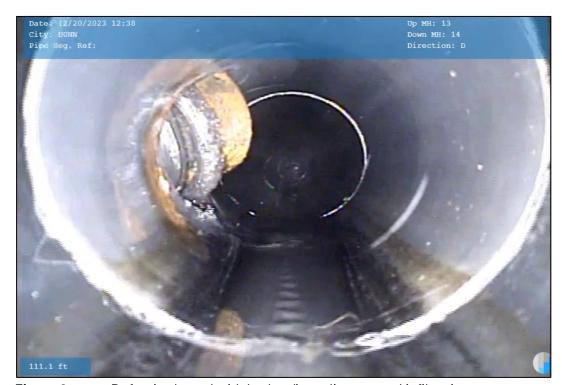
Figure 6: Defective lateral with broken/intruding tap and infiltration.

Upstream Manhole: 13, Downstream Manhole: 14

Address: 3054 Shaw Ct.

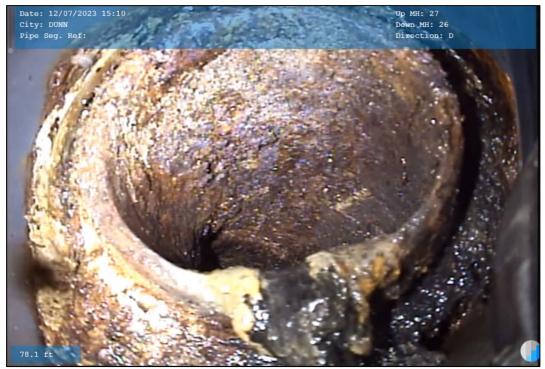
Figure 7: Defective lateral with corrosion and deposits.
Upstream Manhole: 27, Downstream Manhole: 26
Address: 4377 Alma Rd.

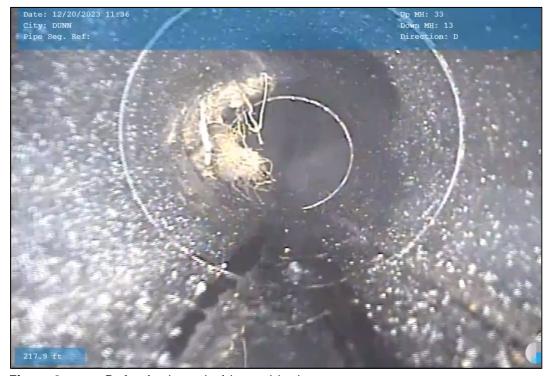
Figure 8: Defective lateral with root blockage.

Upstream Manhole: 33, Downstream Manhole: 13

Address: 3036 Waubesa Ave.

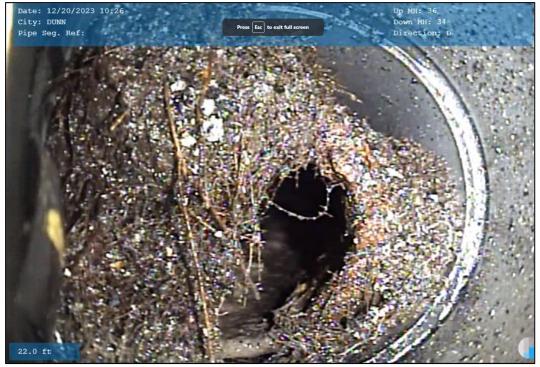
Figure 9: Defective lateral with root blockage.

Upstream Manhole: 36, Downstream Manhole: 34

Address: 3010 Waubesa Ave.

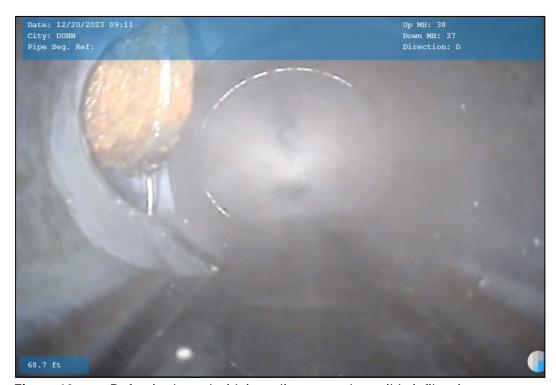
Figure 10: Defective lateral with intruding tap and possible infiltration.

Upstream Manhole: 38, Downstream Manhole: 37

Address: 3004 Waubesa Ave.

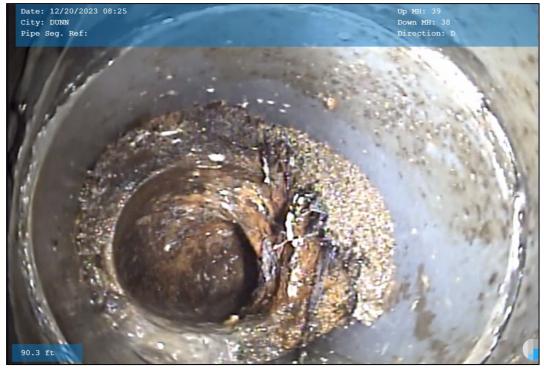
Figure 11: Defective lateral with corrosion, deposits, and roots.
Upstream Manhole: 39, Downstream Manhole: 38
Address: 2998 Waubesa Ave.

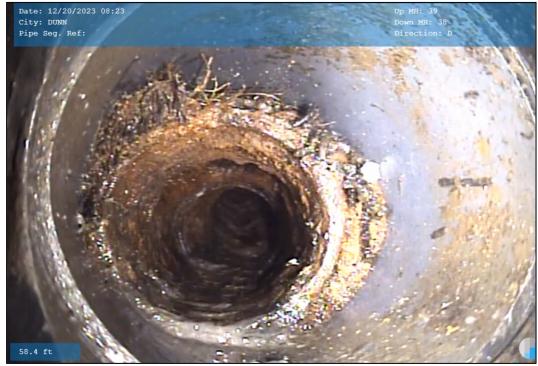
Figure 12: Defective lateral with corrosion, deposits, and roots.
Upstream Manhole: 39, Downstream Manhole: 38
Address: 2996 Waubesa Ave.

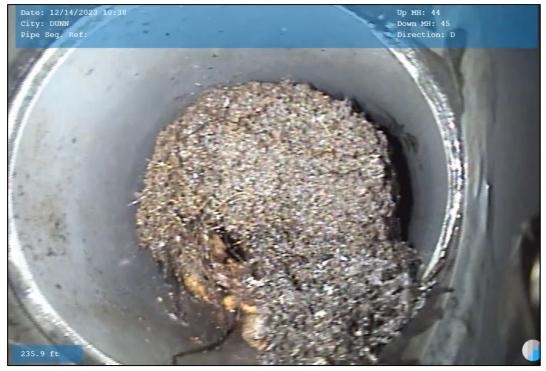
Figure 13: Defective lateral with root blockage.

Upstream Manhole: 44, Downstream Manhole: 45

Address: 2976 Waubesa Ave.

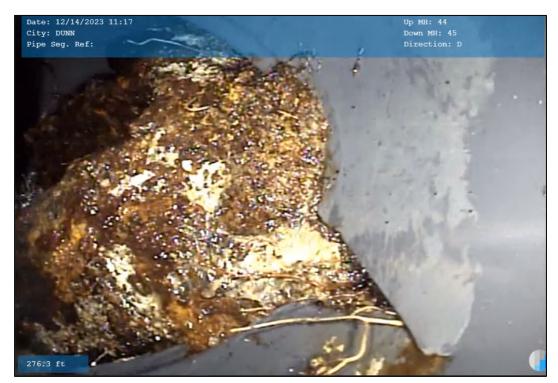
Figure 14: Defective lateral with broken/intruding tap.

Upstream Manhole: 44, Downstream Manhole: 45

Address: 2974 Waubesa Ave.

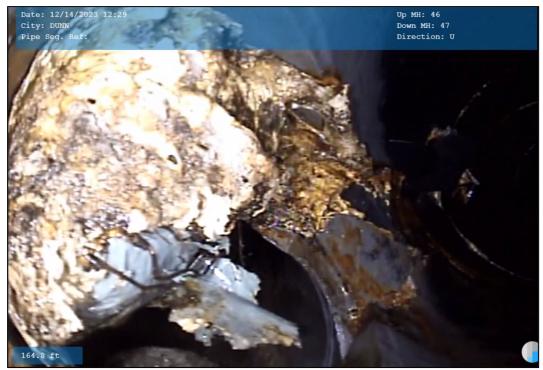
Figure 15: Defective lateral with broken/intruding tap and deposits.
Upstream Manhole: 46, Downstream Manhole: 47
Address: 2966 Waubesa Ave.

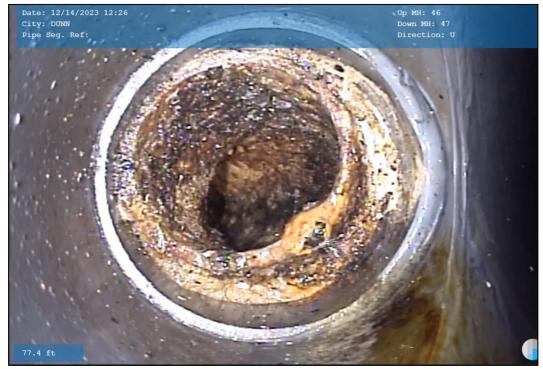
Figure 16: Defective lateral with corrosion and deposits.

Upstream Manhole: 46, Downstream Manhole: 47

Address: 2964 Waubesa Ave.

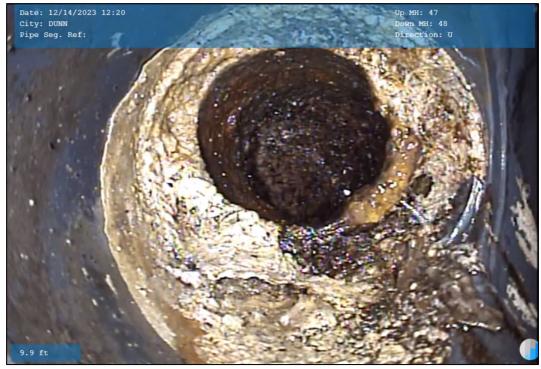
Figure 17: Defective lateral with corrosion and deposits.
Upstream Manhole: 47, Downstream Manhole: 48
Address: 2960 Waubesa Ave.

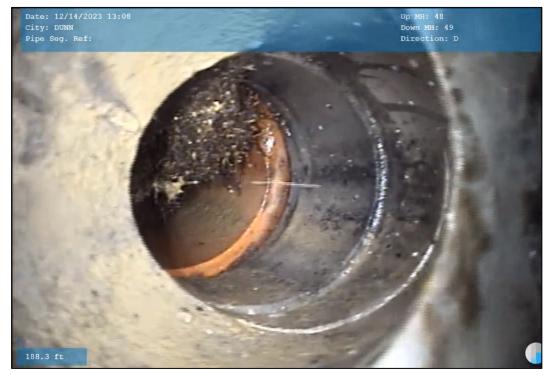
Figure 18: Defective lateral with root blockage.

Upstream Manhole: 48, Downstream Manhole: 49

Address: 2954 Waubesa Ave.

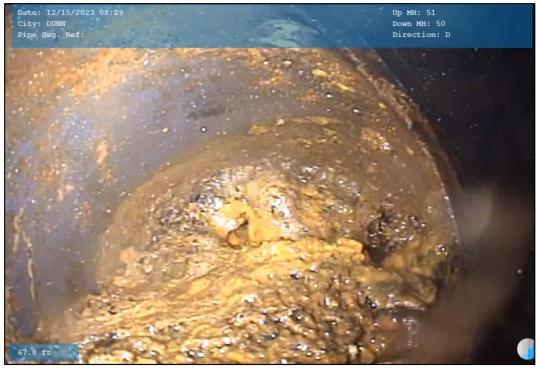
Figure 19: Possible lateral pipe or cap collapse.

Upstream Manhole: 51, Downstream Manhole: 50

Address: None

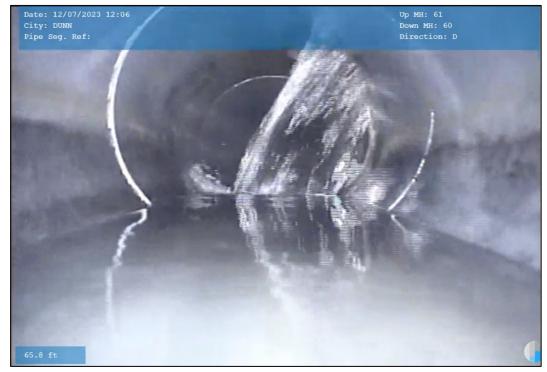
Figure 20: Possible lateral break with significant inflow/infiltration.

Upstream Manhole: 61, Downstream Manhole: 60

Address: 2894 Waubesa Ave.
