July 18, 2025

Subject: Town of Dunn Sanitary District No. 1 - Defective Sanitary Sewer Laterals Update

Photographs from Properties with Major Defects

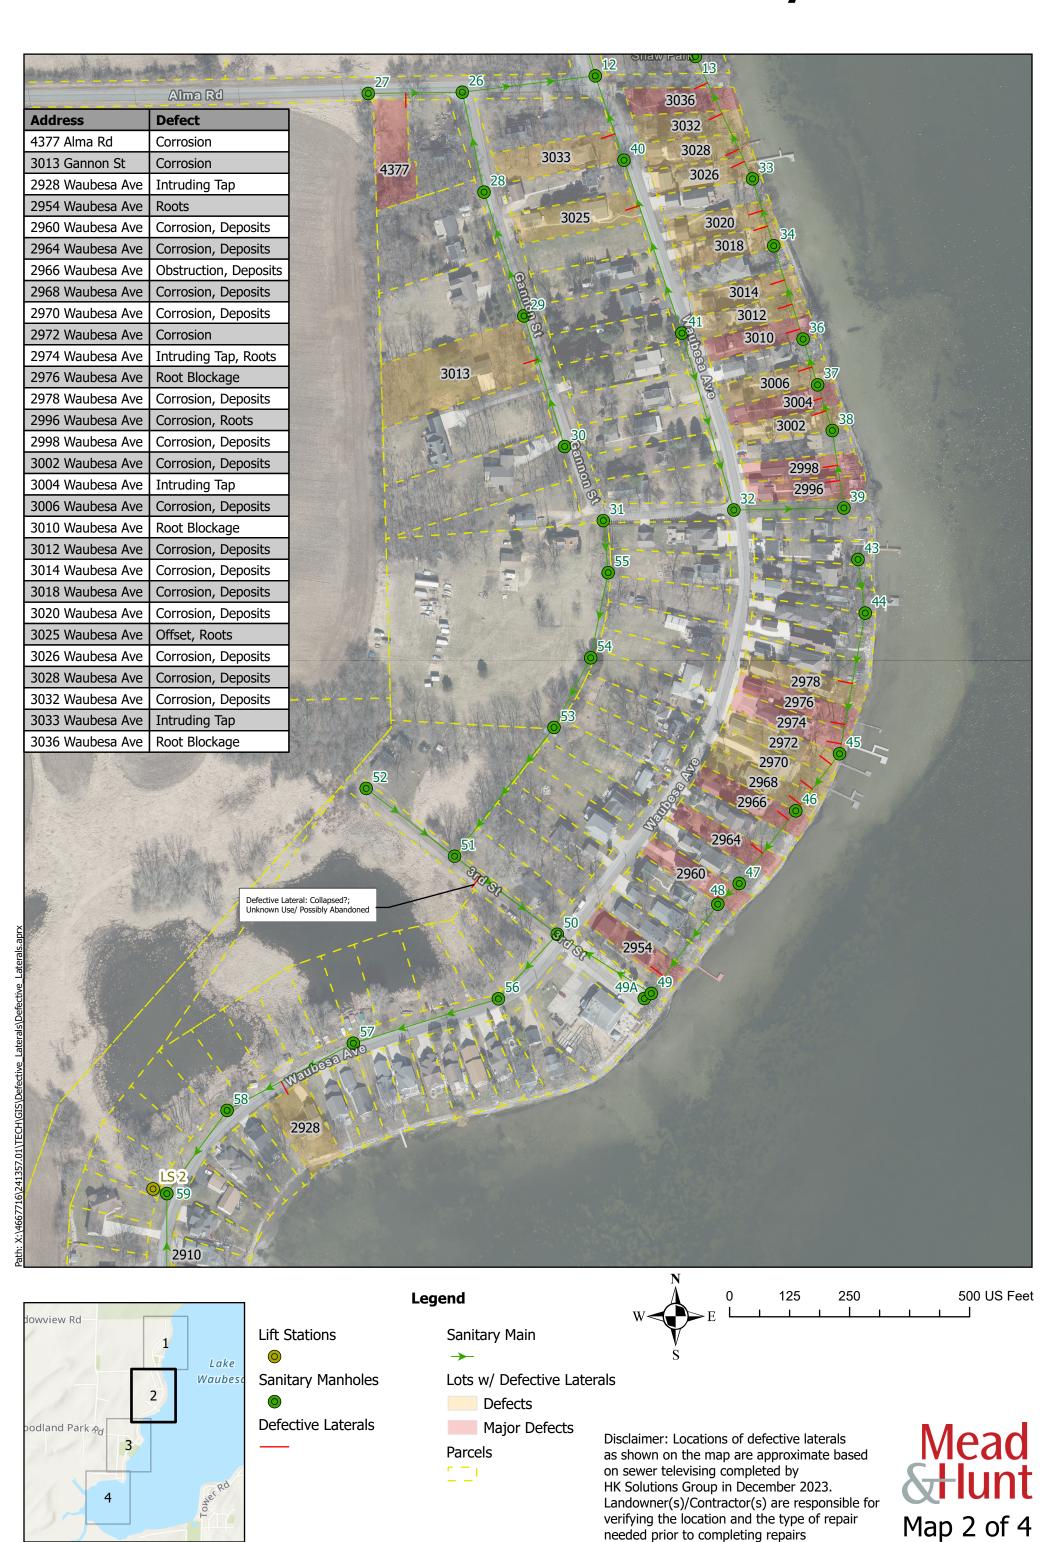
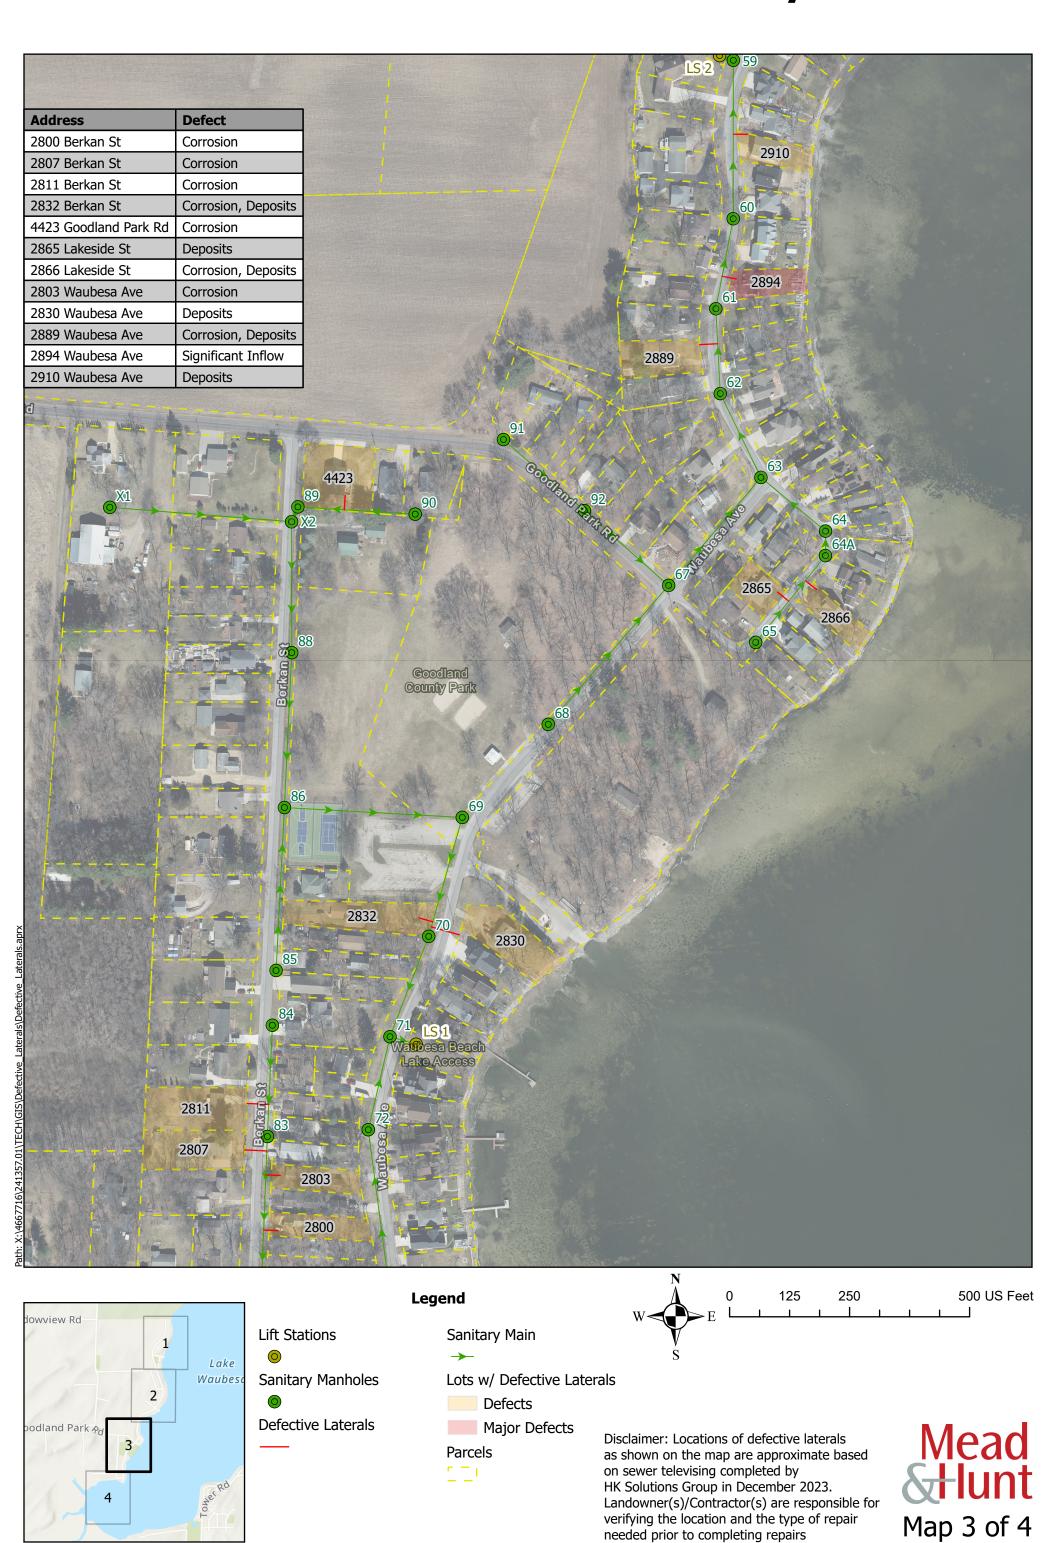
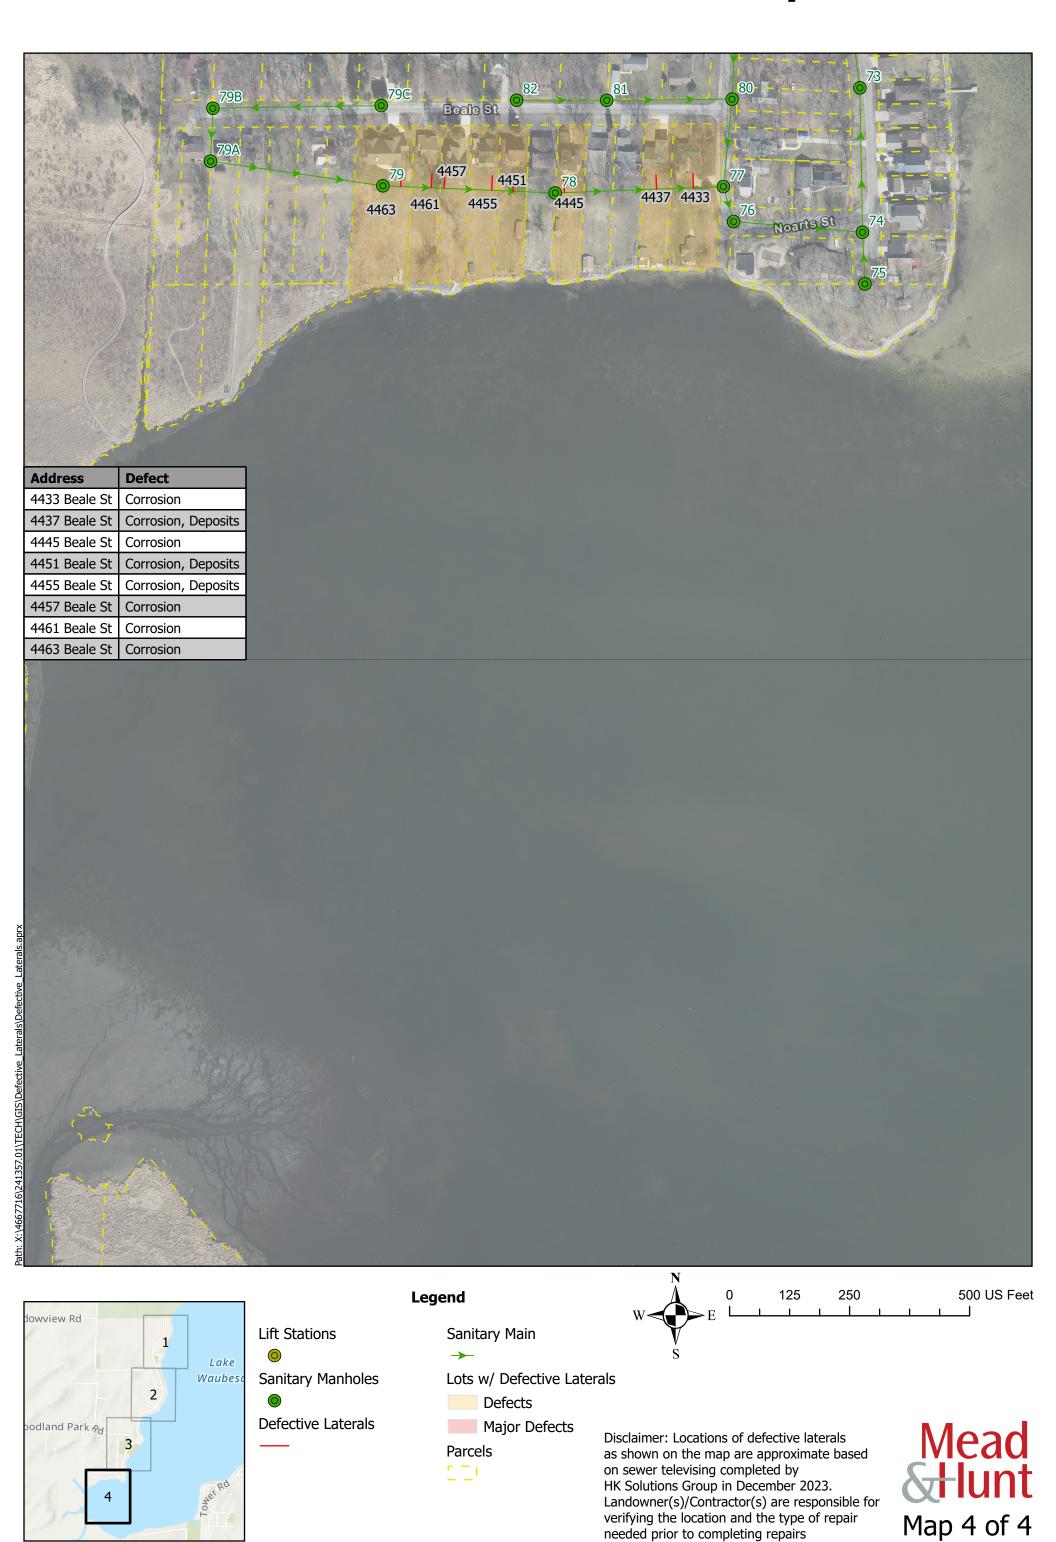
The enclosed maps indicate land parcels where defective private sewer laterals are possibly located. Nineteen (19) laterals appear to have major defects, which the District should prioritize for repair. Eighteen (18) of these laterals are indicated by properties that are shaded in **red** on the maps. One (1) lateral with major defects does not appear to be associated with an existing residential property. This lateral is located along 3rd Street between Manholes 50 and 51 and is indicated by a leader and text on Map 2 of 4. We assume this is a collapsed lateral pipeline or cap that was originally installed in the 1970s, and the adjacent property was never developed due to nearby wetlands.

Another forty-five (45) properties with lower priority lateral defects are indicated by **yellow** shading. These laterals should also be considered for repair but appear less likely to be contributing to excessive infiltration and inflow or sewer main blockages at this time.

On map 1 of 4, we indicated the location where it appears a small diameter pipe or similar object was installed through the walls of the existing sewer main, causing infiltration of clear water into the sewer. This location is currently planned to be repaired as part of the upcoming DNR Clean Water Fund Program project in 2026. Although this is not a lateral defect, it is included with our documentation in case the District feels the need to contact the property owner prior to the start of the 2026 project.

Mead & Hunt recommends contacting each property owner with a possible sewer lateral defect. Repairing and/or replacing these laterals will help prevent infiltration and inflow of clear water into the District's existing sanitary sewer mains. This will reduce wastewater pumping and save operation and maintenance costs at the District's lift stations and reduce wastewater treatment fees charged by MMSD. Repair and/or replacement of these laterals may also help prevent possible sewer backups in identified homes and buildings.

Please note that due to the limitations of this mapping effort, property owners should consider having their lateral televised to determine the extent and severity of possible defects prior to construction. Property owners and contractors are responsible for verifying the location of the lateral outlet or tap into the sewer main, the point of connection of the lateral at the associated home or building, the lateral pipeline length, diameter, and bury depth, etc. Additional verification is required since the locations shown on the enclosed maps are only a "best estimate" of where the underground laterals may be.
